LINKING SMALLHOLDER FARMERS TO MARKET

MANAGEMENT OF FEEDER ROADS IN SIERRA LEONE FOR ENHANCED SUSTAINABILITY

3.2 Inventory and Condition of Study Roads

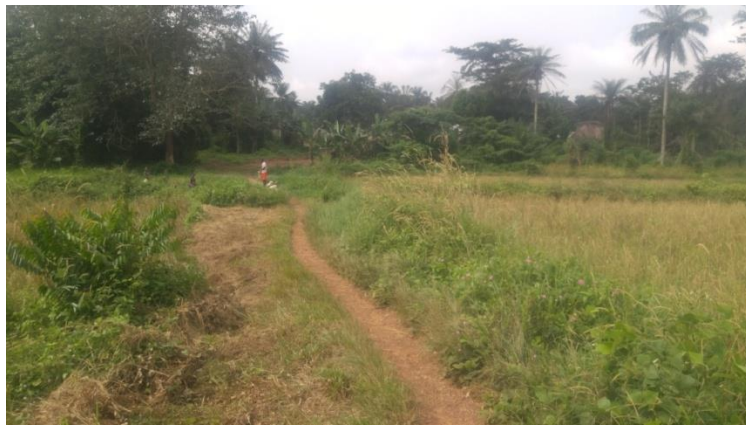
Figure 3.1: Vegetation on road; road reduced to a track

Existing Carriageway Width	≤ 4.0 m
Type/Likely Original Design Class	Non Engineered road ; No apparent Design Class
Surface Type	Earth with residual gravel in some places;
Surface Condition	Vegetation in carriageway; gully erosion in some places; flat surface with no apparent crossfall.
Lateral drainage	No side drain evident
Transverse drainage	Few existing under – sized pipe culverts; wide streams are impassable by vehicles; logs are provided for pedestrian crossing
Horizontal alignment	Appears as if this has never been rigorously designed
Vertical alignment	Appears as if this has never been rigorously designed. Locations exist where gradients are steep, approaching 10%.
Terrain type	Flat to gentle (Type F)
Traffic level (ADT)	Definitely less than 100 veh/day (No vehicles observed on road)
Average Travel Speed based on Travel Time runs on passable sections	15.0 km/hr

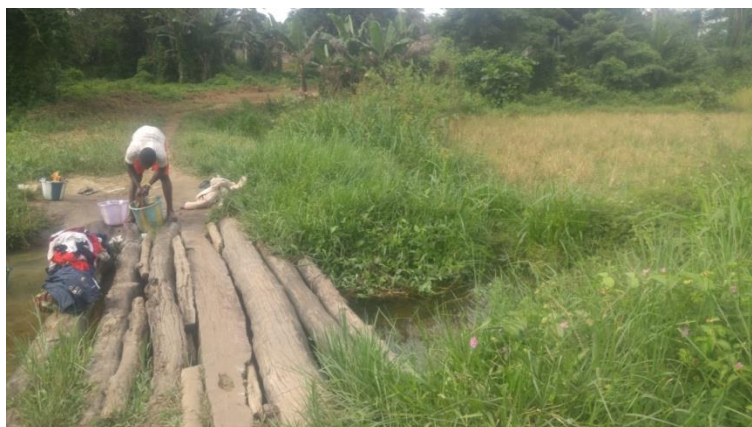
Figure 3.2: Road virtually Impassable ; Log palms for Crossing

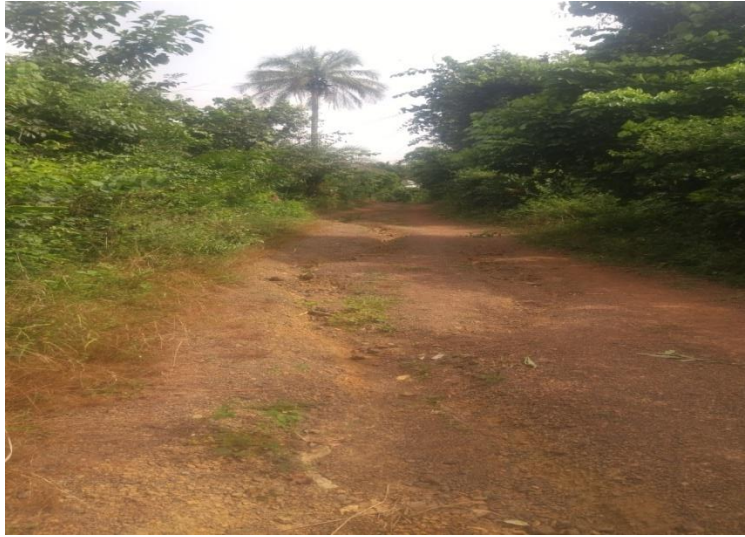
Figure 3.3: Gullies and Steep Gradient

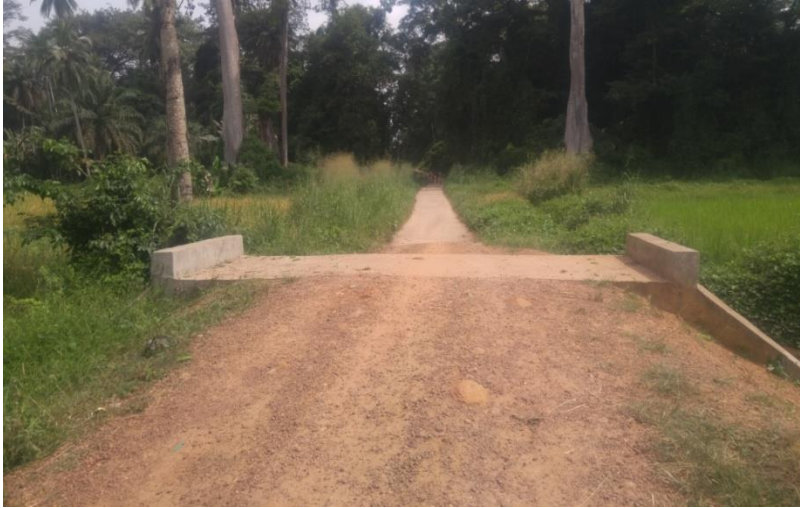
Figure 3.4 Road with Newly Constructed Culvert

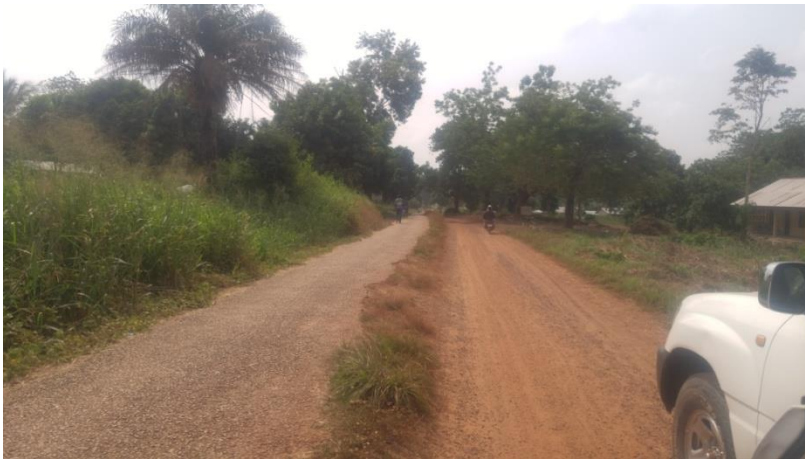
Figure 3.5: Evidence of Previous Surface Treatment Wearing Course on Road

Existing Carriageway Width	≤ 4.0 m. Reduced to tracks in some locations 2.0m wide
Type/Likely Original Design Class	Engineered road ; Design Class not adhered to.
Surface Type	Evidence that road was once paved up to some point with Single Surface Treatment of bitumen and chippings; residual gravel surface evident in some places;
Surface Condition	Vegetation narrowed carriageway in some places; flat surface with no apparent crossfall.
Lateral drainage	No side drain evident
Transverse drainage	Evidence of recent intervention to construct some culverts; Some wide streams are however still impassable by vehicles; logs are provided for pedestrian crossing. Need for box culverts across wide streams.
Horizontal alignment	Appears as if this has never been rigorously designed
Vertical alignment	Appears as if this has never been rigorously designed. Locations exist where gradients are steeper than 10%.
Terrain type	Flat to gentle (Type F)

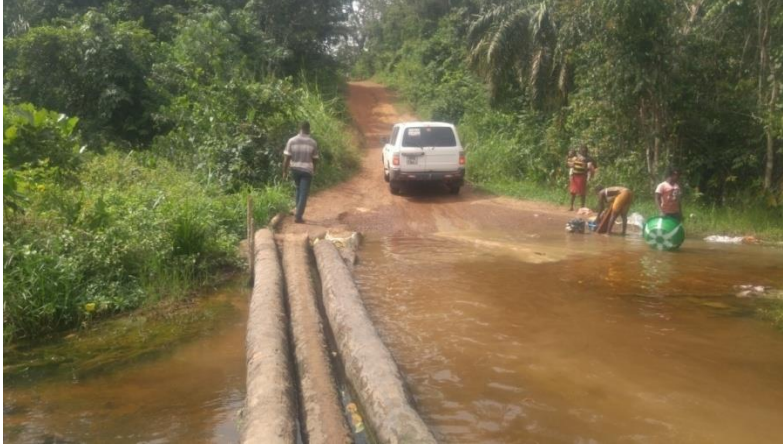
Figure 3.6: Road Becomes Impassable at Wide Stream; Steep Gradient Evident.

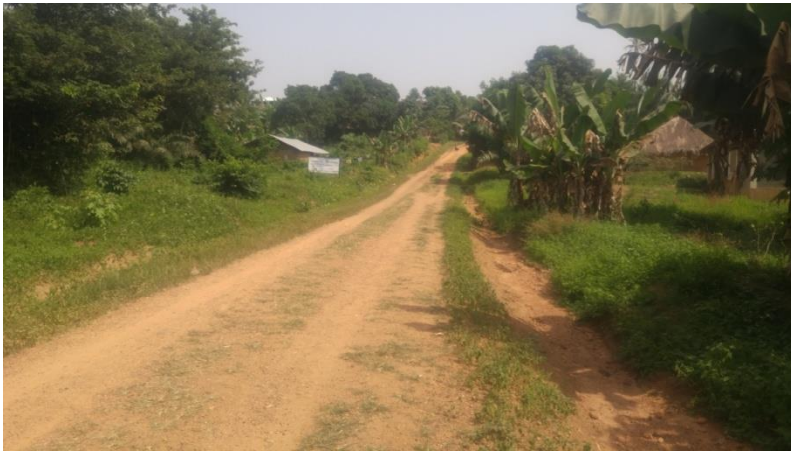
Figure 3.7: Apparent Engineered Road; Evidence of Side Drains Recently Constructed

Existing Carriageway Width	≤ 4.0 m. Reduced to tracks in some locations 2.0m wide
Type/Likely Original Design Class	Apparent Engineered gravel road ; Design Class not adhered to.
Surface Type	Residual gravel surface evident in some places; gravel surfacing has all been washed off .
Surface Condition	Vegetation narrowed carriageway in some places; flat surface with no apparent crossfall.
Lateral drainage	On – going works shows recently constructed side drains.
Transverse drainage	Evidence of on -going intervention to construct culvert; although work has stopped at the time of visit; contractor seem to have abandoned works. Road now impassable at excavated culvert location.
Horizontal alignment	Appears as if this was never rigorously designed;
Vertical alignment	Appears as if this was never rigorously designed. Locations exist where gradients are steeper than 10%.
Terrain type	Flat to gentle (Type F)

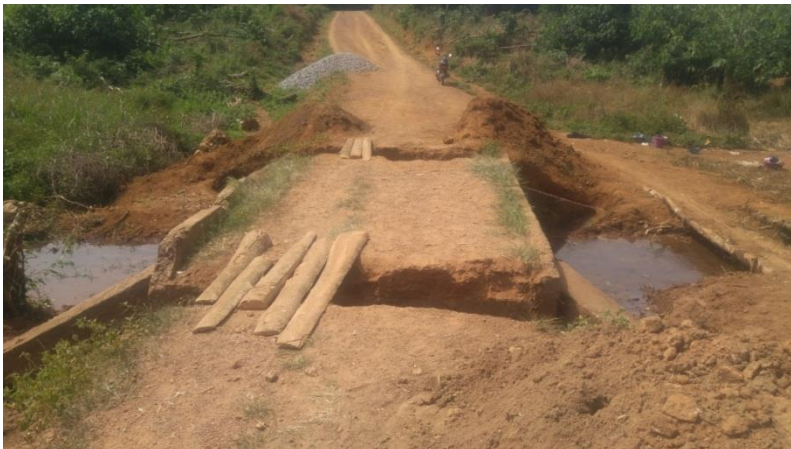
Figure 3.8: On- going Unsupervised Works to Construct Culvert

There does not appear to have been any engineering standards complied with during rehabilitation of the roads; this is responsible for the typical observation of poor road surface with no crossfall, dangerous horizontal curves and challenging vertical curves; no side drainage exacerbated by lack of crossfall causes water to pond on the roads resulting to pavement deterioration and consequent impassability.

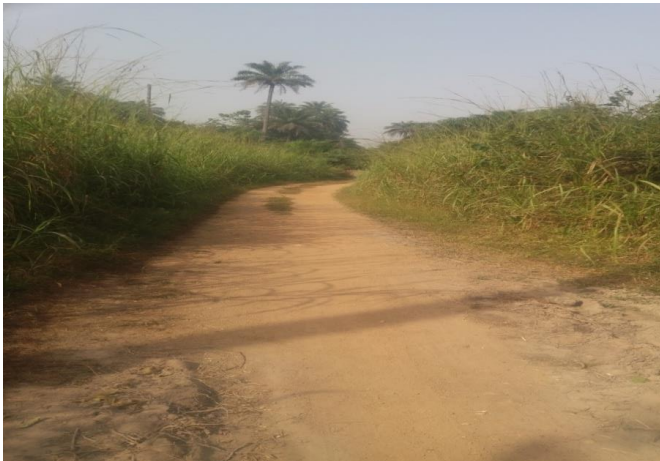
Figure 3.9: No gravel surface layer; Dangerous S - Curve

Existing Carriageway Width	3.5m. average carriageway; cannot accommodate two vehicles at most locations
Type/Likely Original Design Class	No engineering design standard complied with; Earth riding surface with no gravel covering.
Surface Type	Earth
Surface Condition	Vegetation narrowed carriageway in most places; flat surface with no crossfall. Dusty road; will be slippery and difficult to ride on in the rainy season.
Lateral drainage	None
Transverse drainage	Culverts exist but silted and not flowing; potential to overtop in rainy season.
Horizontal alignment	No Design standard complied with; appears as if it was never designed; tight, dangerous curves with very little sight distance.
Vertical alignment	Appears as if this was never rigorously designed. Locations exist where gradients are steeper than 10%, causing gulley erosion.
Terrain type	Flat to gentle (Type F)
Traffic level (ADT)	Definitely less than 100 veh/day. (No vehicle observed on road)

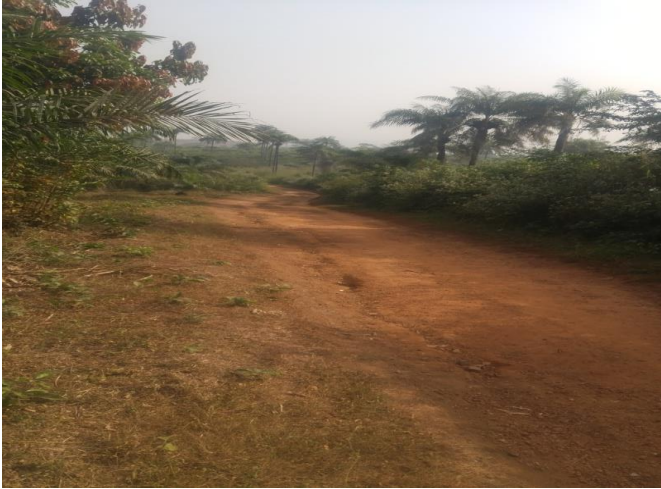
Figure 3.10: Tight Dangerous Curves, Steep gradients, Gully Erosion

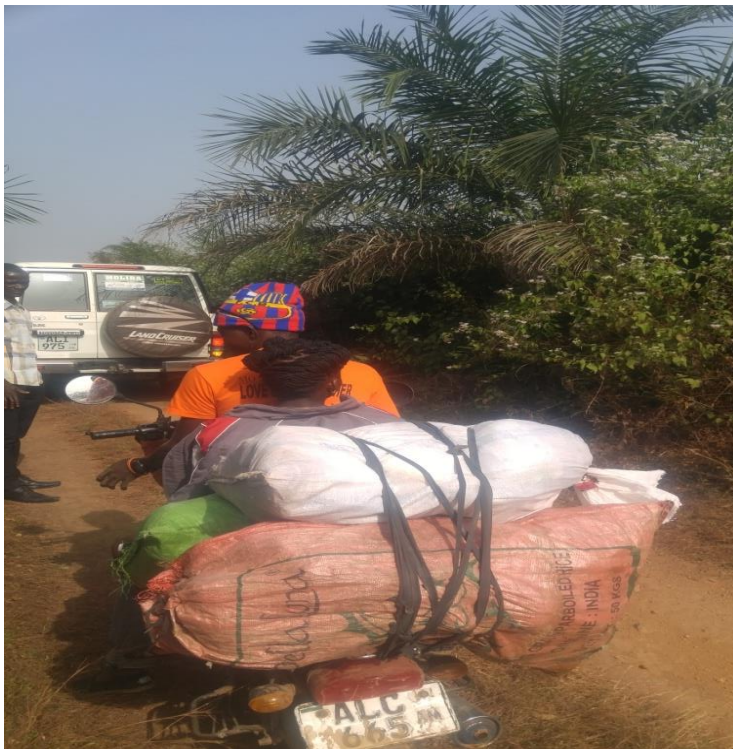
Figure 3.11: Typical Challenges Taking Produce To Markets

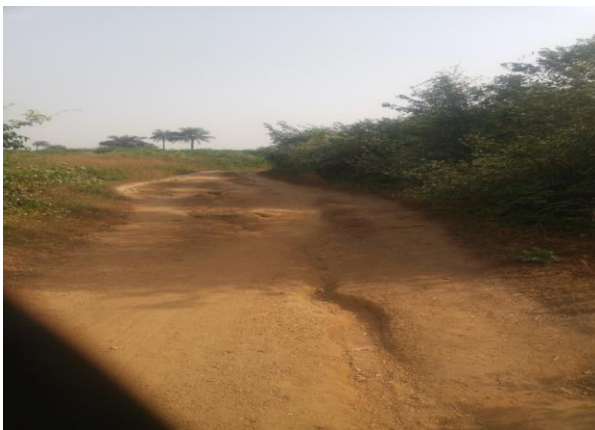
Figure 3.12: Steep Slope; Tight Curves with Gulley Erosion

Existing Carriageway Width	3.5m. average carriageway; cannot accommodate two vehicles at most locations
Type/Likely Original Design Class	No engineering design standard complied with; Earth riding surface with no gravel covering.
Surface Type	Earth
Surface Condition	Vegetation narrowed carriageway in most places; flat surface with no crossfall. Dusty road; will be slippery and difficult to ride on in the rainy season.
Lateral drainage	None
Transverse drainage	Culverts exist but silted and not flowing; potential to overtop in rainy season.
Horizontal alignment	Design standard not complied with; No apparent engineering design; tight , dangerous curves with very little sight distance.
Vertical alignment	Appears as if this was never rigorously designed. Locations exist where gradients are steeper than 10%, causing gulley erosion.
Terrain type	Flat to gentle (Type F)
Traffic level (ADT)	Definitely less than 100 veh/day. No Vehicle observed on road)

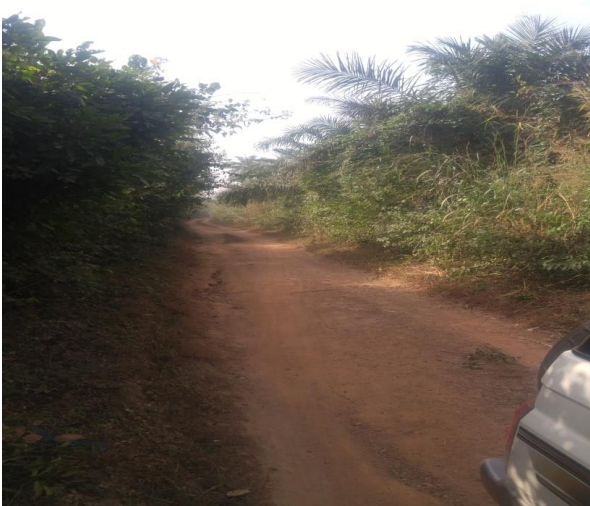
Figure 3.13: Virtually no gravel on surface; washed out.

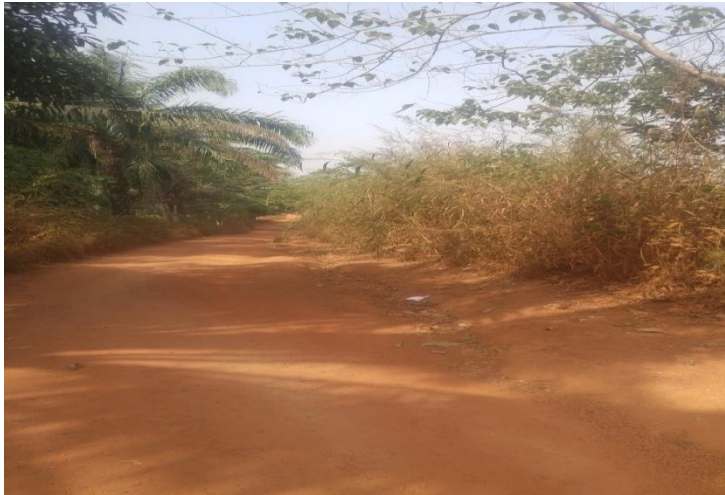
Figure 3.14: Poor Road Geometry; Gulley Erosion; Overgrown Vegetation

Existing Carriageway Width	3.0m. average carriageway; cannot accommodate two vehicles at most locations
Type/Likely Original Design Class	Apparent engineered road but no engineering design standard complied with
Surface Type	Residual gravel; most washed off.
Surface Condition	Overgrown vegetation narrows road width; flat surface with no crossfall. Surface rideable with difficulty.
Lateral drainage	None; overgrown by vegetation
Transverse drainage	Culverts are in good condition
Horizontal alignment	Design standard not complied with; tight , dangerous curves exist.
Vertical alignment	Appears as if this was never rigorously designed.
Terrain type	Flat to gentle (Type F)
Traffic level (ADT)	Definitely less than 100 veh/day. (No vehicle on road)
Average Travel Speed based on Travel Time runs on passable sections	22.0 km/hr

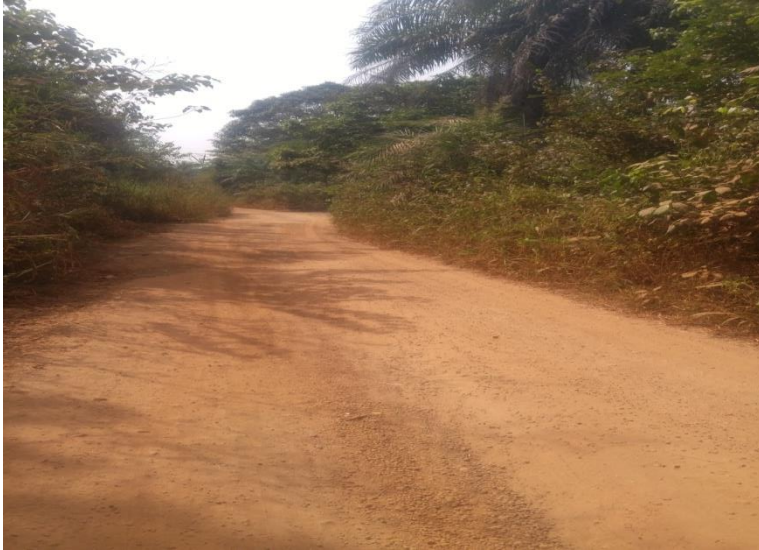
Figure 3.15: Dangerous Tight Curve; Vegetation Restricting Width of Carriageway

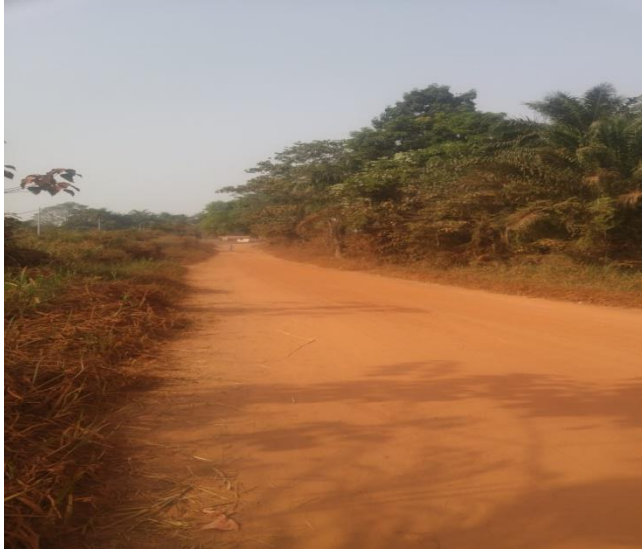
Figure 3.16: Relatively good gravel road; Overgrown Vegetation at Edge of Road

Existing Carriageway Width	5.0m. average carriageway
Type/Likely Original Design Class	Engineered road .
Surface Type	Gravel
Surface Condition	Reasonably good, although bumpy when driving because of corrugations; dusty road conditions
Lateral drainage	No definite side drains; overgrown vegetation at edge of road; this can cause water to be trapped on roadway.
Transverse drainage	Culverts are in good condition
Horizontal alignment	PParent engineering design followed
Vertical alignment	Appears this was properly designed.
Terrain type	Flat to gentle (Type F)
Traffic level (ADT)	More than 100 veh/day.
Average Travel Speed based on Travel Time runs on passable sections	33.0 km/hr

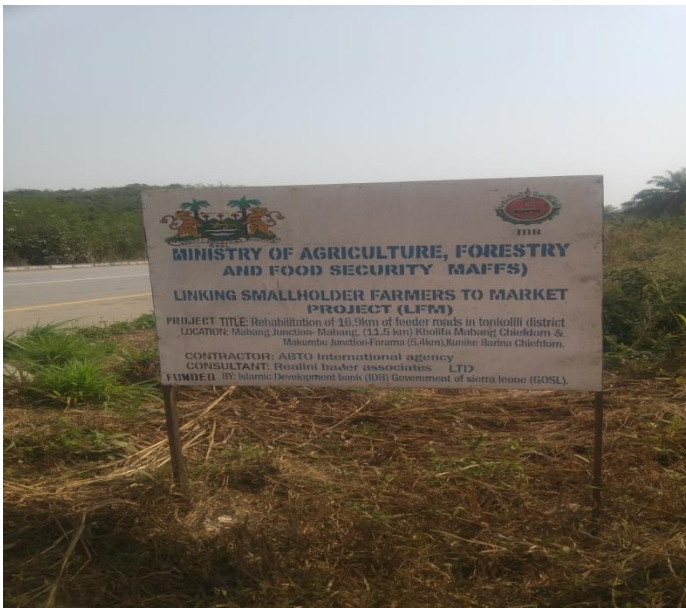
Figure 3.17: Recently Rehabilitated LFM Road - Sign Board

A classical case of poor implementation of rehabilitation works is seen at the Makumbu junction – Farama road, which is a recently rehabilitated LFM road (see Figsto). The evidence indicated that no proper engineering design was done, supervision was poor or non – existent and part of the road even appeared untouched.

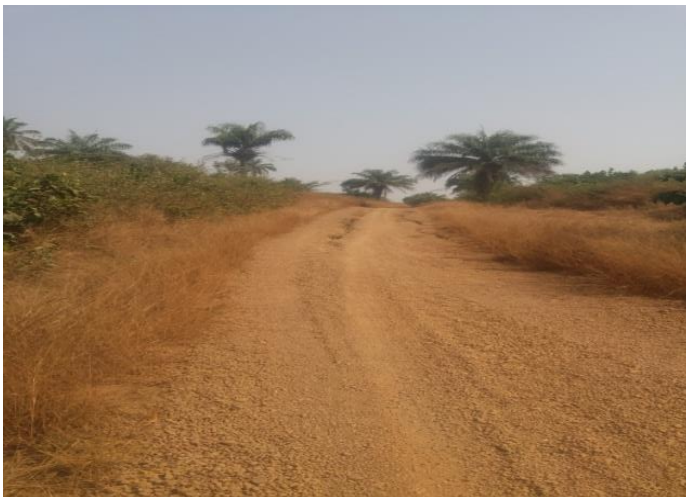
Figure3.18: Extremely Steep slope

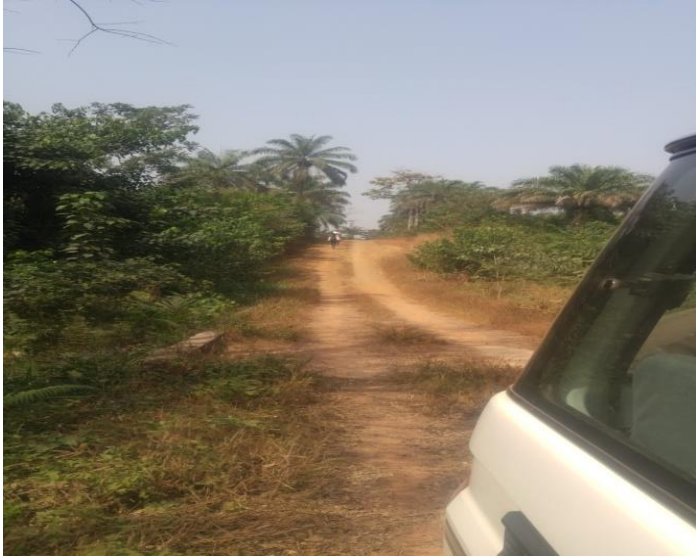
Figure3.19: Poorly Designed Section; Seem Untouched

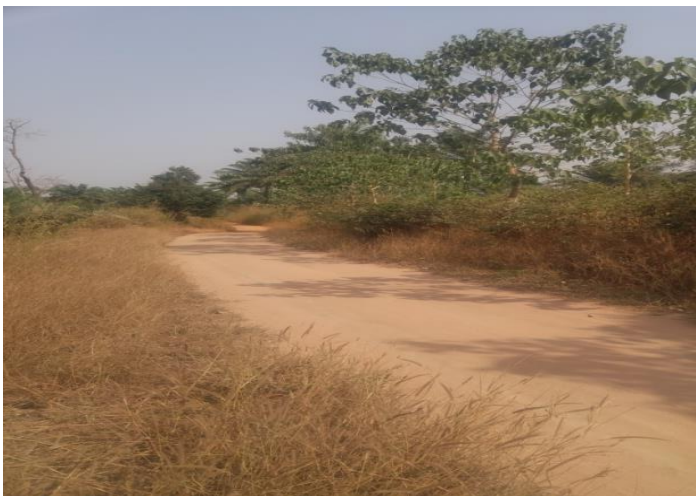
Figure 3.20: Poorly Engineered Tight Curves

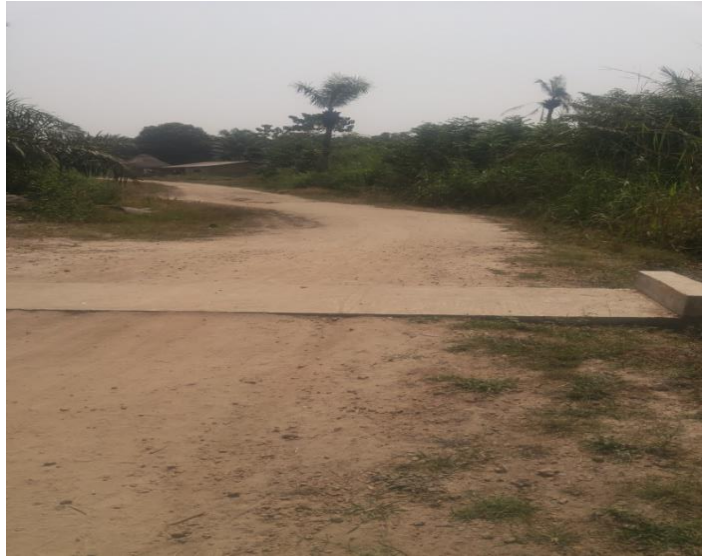
Figure 3.21: No Surface Gravel

Existing Carriageway Width	3.0m average carriageway; below required design standard; overgrown vegetation on side of road.
Type/Likely Original Design Class	Poorly engineered road
Surface Type	Residual gravel; some areas without gravel surface material
Surface Condition	Very poor for a road that is supposed to have been recently rehabilitated; dusty conditions
Lateral drainage	No side drains evident. Overgrown vegetation; no routine Maintenance apparent since rehabilitation.
Transverse drainage	Culverts are in good condition
Horizontal alignment	Very poor engineering design ; curves very tight and dangerous.
Vertical alignment	Poorly designed, or no design at all; very steep challenging gradients.
Terrain type	Rolling to Mountainous (Type H)
Traffic level (ADT)	Less than 100veh/day.
Average Travel Speed based on Travel Time runs on passable sections	14.0 km/hr

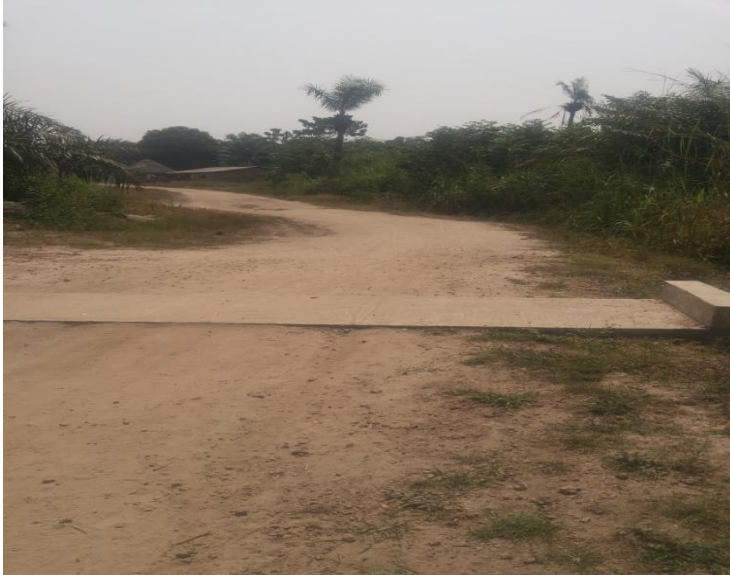
Figure 3.22: Tight Curve; Earth Surface

Existing Carriageway Width	3.0m average carriageway; below required design standard;
Type/Likely Original Design Class	No apparent engineering design;
Surface Type	Earth
Surface Condition	Very poor; earth surface which has the potential of becoming very slippery during the rainy season.
Lateral drainage	No side drains evident.
Transverse drainage	Culverts unfinished
Horizontal alignment	Very poor engineering design ; curves very tight and dangerous.
Vertical alignment	No apparent engineering design
Terrain type	Flat to gentle rolling (Type F)
Traffic level (ADT)	Definitely less than 100 VPD; none using road
Average Travel Speed based on Travel Time runs on passable sections	20.0 km/hr

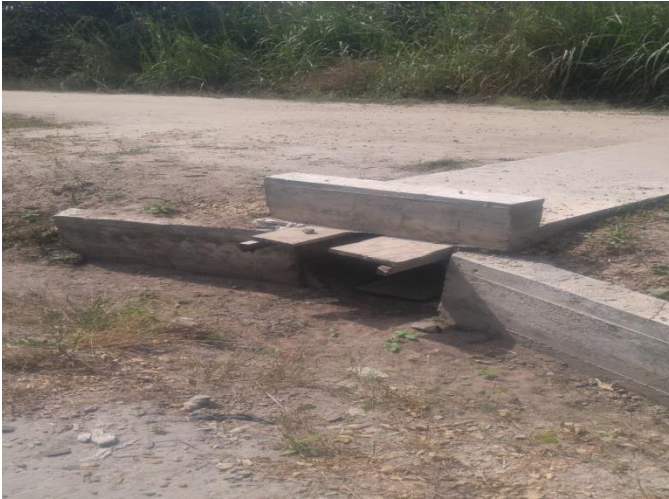
Figure 3.23: Abandoned Work at Culvert Location

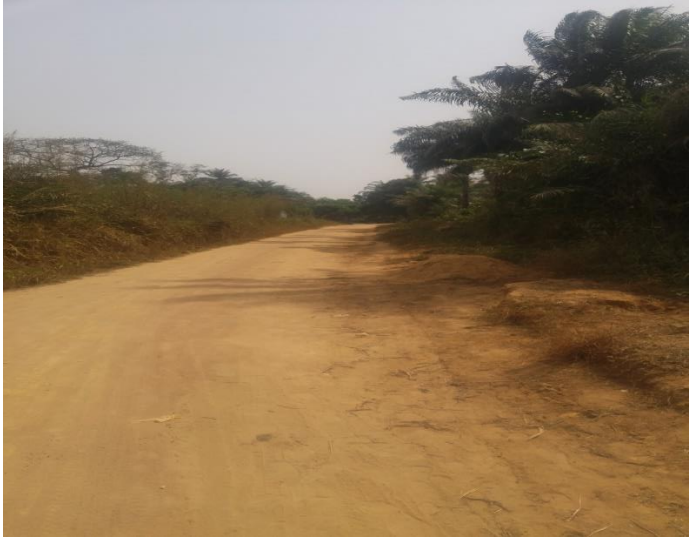
Figure 3.24: Reasonably Rideable Earth Surface

Existing Carriageway Width	4.0m average carriageway
Type/Likely Original Design Class	Un - engineered road
Surface Type	Earth
Surface Condition	Uneven Earth surface with depressions ; passable in dry season, but clayey sand material would be slippery during the rainy season.
Lateral drainage	Efforts being made to dig side drains
Transverse drainage	None
Horizontal alignment	Poor; No Geometric standards followed.
Vertical alignment	No apparent engineering design
Terrain type	Flat to gentle rolling (Type F)
Traffic level (ADT)	Definitely less than 100 VPD (No vehicle on road)
Average Travel Speed based on Travel Time runs on passable sections	15.0 km/hr

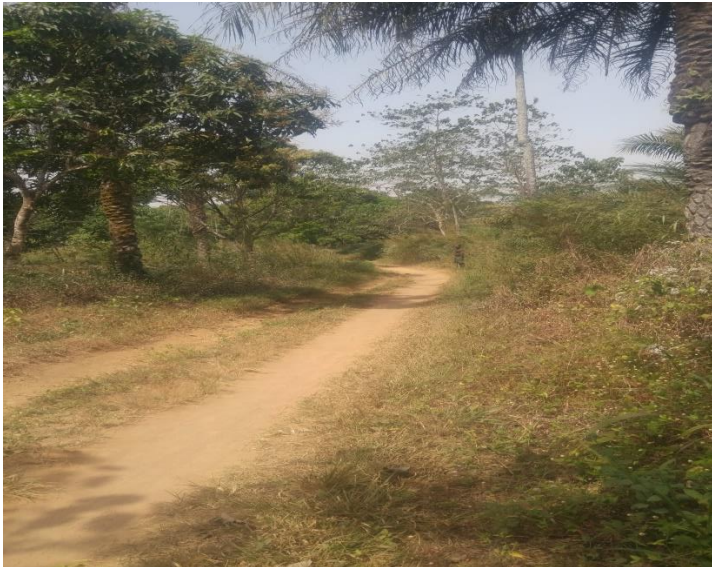
Figure 1.26: A Track With Vegetation on Road

Existing Carriageway Width	4.0m average carriageway
Type/Likely Original Design Class	Un - engineered road
Surface Type	Earth
Surface Condition	Virtually a motor track with vegetation on roadway
Lateral drainage	None
Transverse drainage	None
Horizontal alignment	Not engineered.
Vertical alignment	No engineering design
Terrain type	Flat to gentle rolling (Type F)
Traffic level (ADT)	Definitely less than 100 VPD; no vehicle using road
Average Travel Speed based on Travel Time runs on passable sections	15.0 km/hr

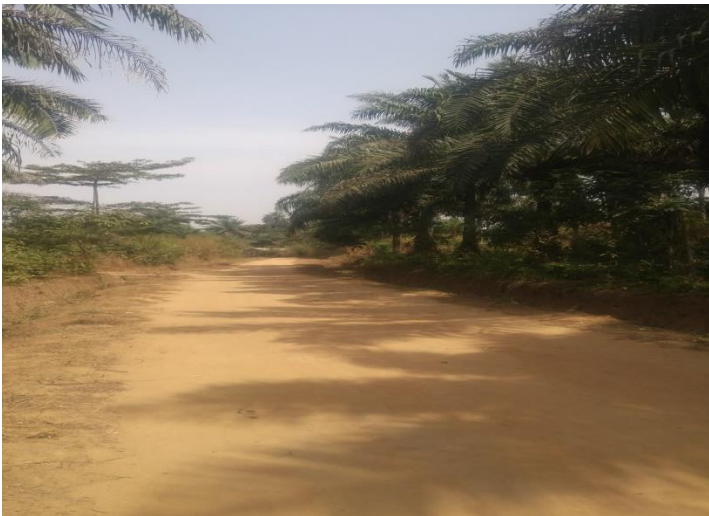
Figure 3.27: Effort Digging Side Drain

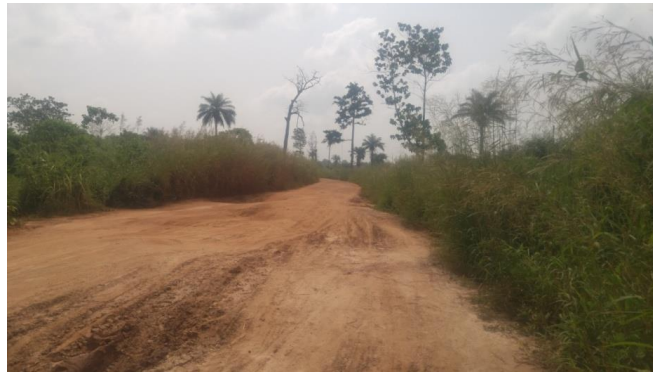
The impact of rehabilitating feeder roads cannot be realized if the secondary roads to which they connect are not well designed and paved.

Figure 3.28: Poor Condition of a Secondary Road: Bo - Mattru Road

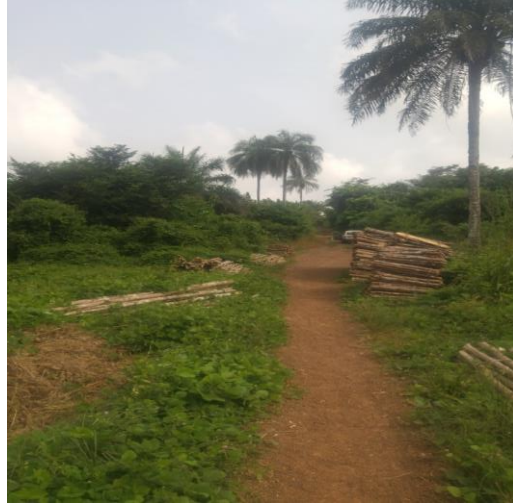
- v. The poor condition of the roads which are impassable for significant periods of the year and preventing farmers to access markets with their produce, is resulting to unwanted and uncontrolled cutting down of trees for firewood, charcoal and bush sticks which they can readily sell to truck drivers that manage to access the roads, because they have to feed their families. These activities have significant negative impact on the environment in terms of Global warming and drought, erosion and landslides.

Figure 3.29: Indiscriminate Cutting of Trees for Wood and Bush Sticks
